CEDAR HILL LAKE NO. 1 DAM
JEFFERSON COUNTY, MISSOURI
MO 30073

**PHASE I INSPECTION REPORT
NATIONAL DAM SAFETY PROGRAM**

JANUARY 1979

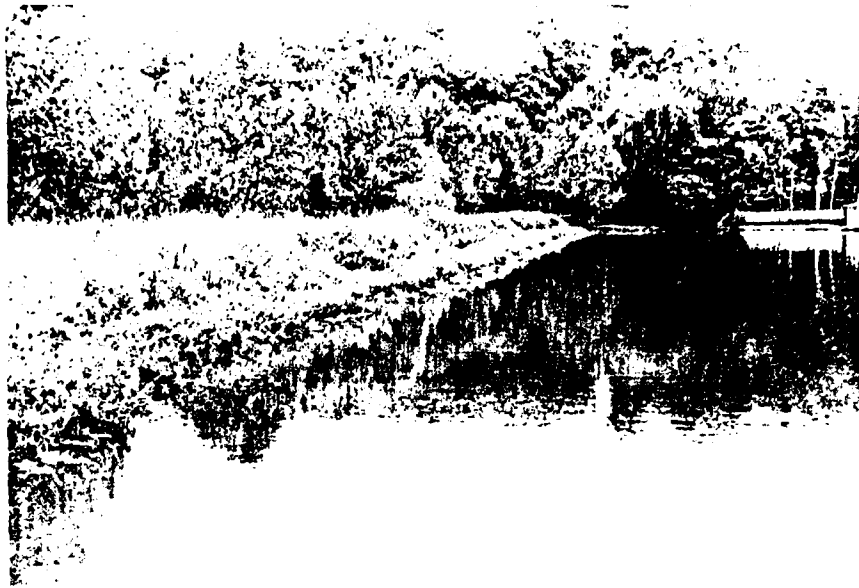
The upstream embankment slope does not have riprap for protection. As a result, some sloughing is occurring near the high water elevation. This has caused some steepening of the embankment slope, with the slope appearing to be as steep as 1V to 1H in some areas. Vegetation on the slope is not satisfactory for protection of the slope from erosion.

The sloughing on the upstream slope of the embankment has not progressed to a serious extent at this time. The condition should be monitored, but no remedial measures are felt to be necessary at this time. Continual sloughing of the embankment materials will necessitate remedial measures at some future date.

Photo 1 - View of upstream slope of embankment taken from left abutment. Spillway is located at far right side of dam.

d. Repair the erosion and sloughing on the upstream embankment slope as is becomes necessary.

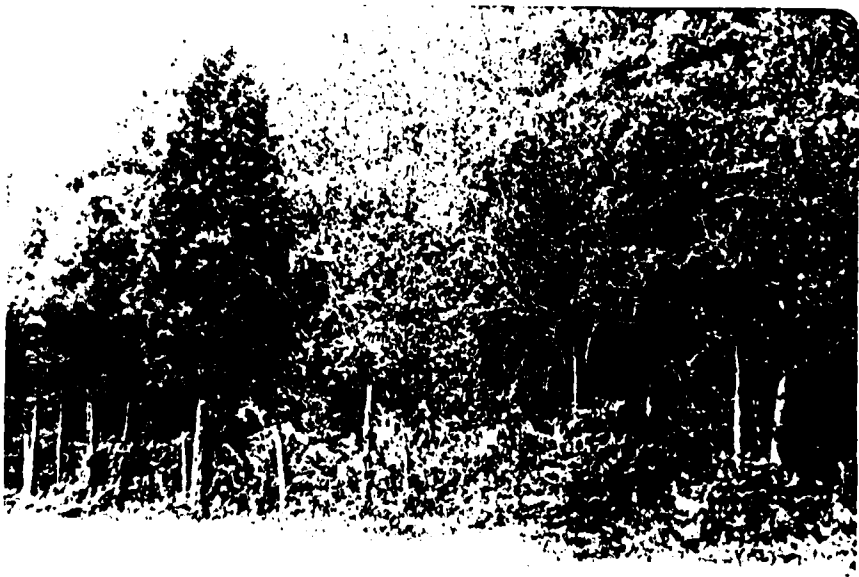
The downstream embankment slope is overgrown with trees and large brush. This heavy vegetation made proper inspection of the slope virtually impossible. Rodent activity was observed on the embankment slope.

Photo 2 - View of typical section of downstream embankment slope.

The heavy vegetative growth, including large trees, on the downstream embankment slope should be cleared as soon as possible. The growth prevents proper inspection of the embankment in addition to providing a hazard to the embankment.

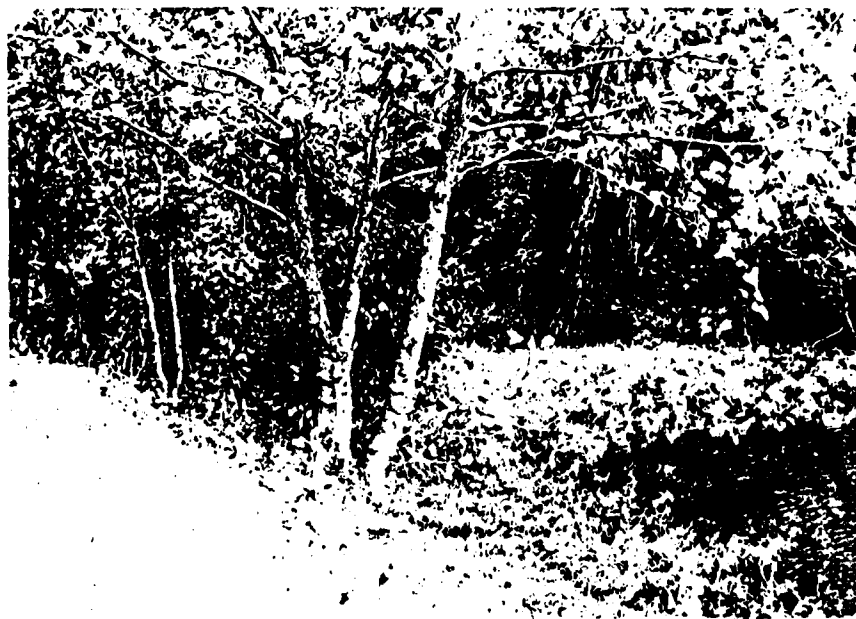
Photo 5 - Picture of approach channel for spillway at right abutment of dam.

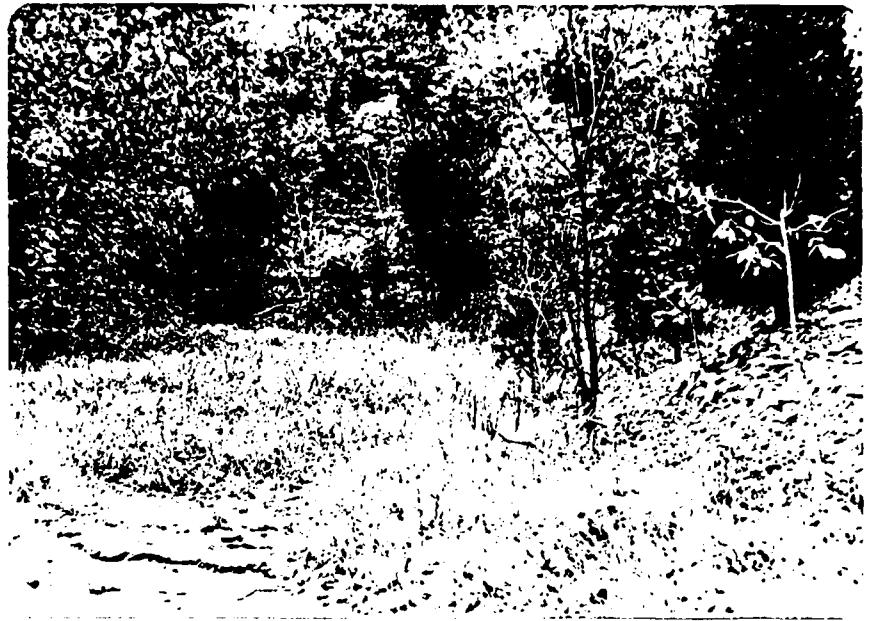
The rock spillway and falls, and the exit channel are well defined and were in good condition. However, the abundance of vegetation in the spillway area would adversely affect the hydraulic efficiency of the structure.

Photo 7 - Picture of spillway channel taken from road looking upstream.
